**U.S. ENVIRONMENTAL PROTECTION AGENCY
POLLUTION/SITUATION REPORT
2015 Gold King Mine Release SITREP**

Subject: SITREP #5
Gold King Mine Release

San Juan County, Colorado
Latitude: 37.8945 Longitude: -107.6384

From: Colorado Unified Command Situation Unit
Date: 08/13/2015
Reporting Period: 08/12/15 through 08/12/15
Website: epa.gov/goldkingmine

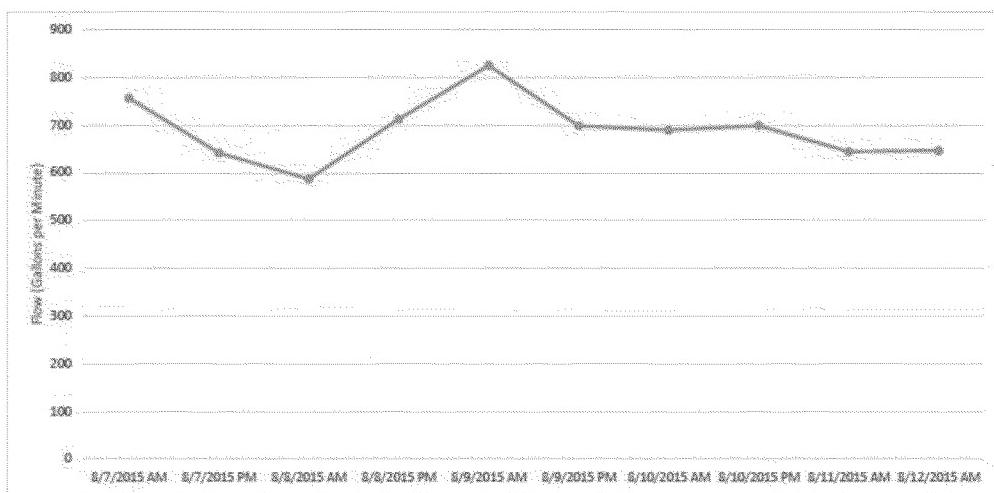
The EPA continues to operate four treatment and sedimentation ponds at the mine site which are treating water by lowering acidity levels and removing dissolved metals. Flow from the mine through the morning of 8/12/2015 is shown in the following chart. **As of 11 am on 8/13/2015, there was no available updated water discharge data available.**

Treated water from the last treatment pond is discharging into Cement Creek at levels cleaner (higher pH and lower levels of metals) than pre-event, background conditions in the creek. Flow data out of the mine is being collected manually two times per day. Water quality data is being collected at the influent and effluent of the treatment system as well.
